# BEACH STABILIZATION TESTS OF LANDING MATS AND PREFABRICATED MEMBRANES

TECHNICAL REPORT NO. 3-592

February 1962

U. S. Army Engineer Waterways Experiment Station  
CORPS OF ENGINEERS  
Vicksburg, Mississippi

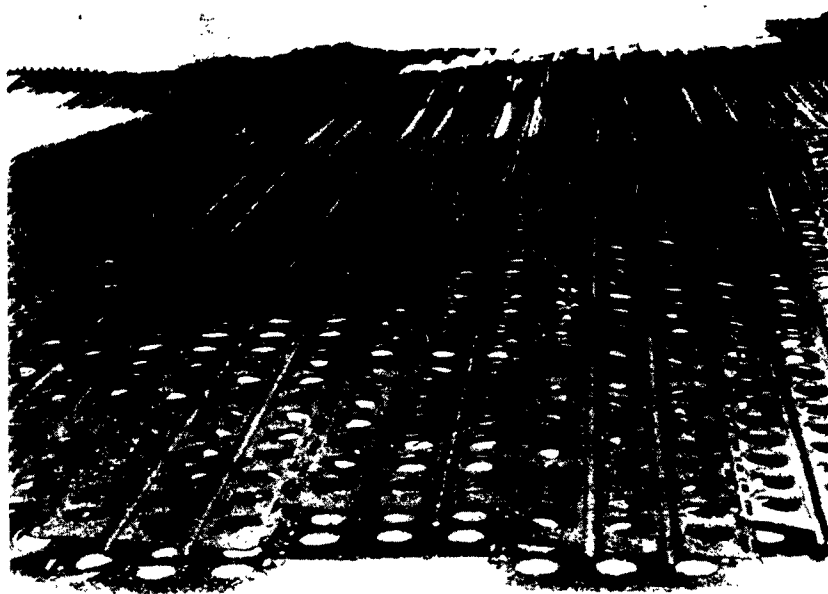
Photograph 15. Scour along southeast edge of lane 3, La Turballe,  
390 passes

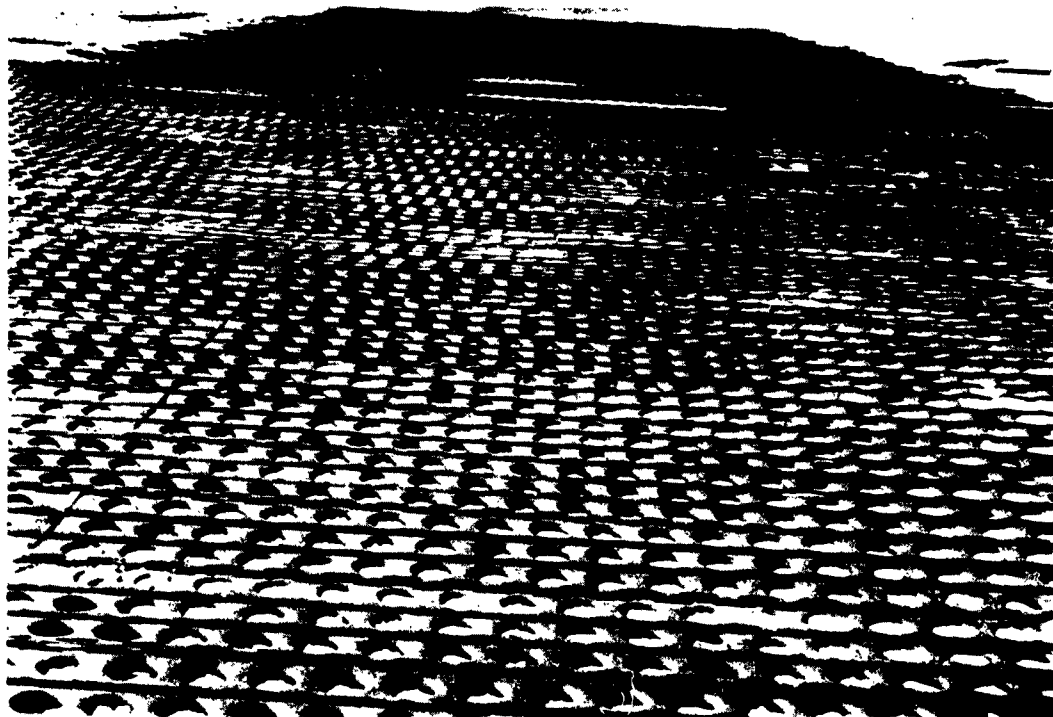
Photograph 28. PSP on lane 2, Suscinio, prior to traffic

was completed on 1 June, and traffic was started on 3 June. A total of 1000 passes with the M51 truck and DUKW were completed on 6 June (table 4). At the beginning of traffic, the mat surface on this lane was generally smooth (photograph 28) and in good condition, although a considerable number of the panels were deformed from previous use. The mat bridged the beach intermittently throughout the lane since no attempt had been made to grade the beach or seat the mat. However, the bridging was less pronounced than that experienced on test lane 2 at La Turballe (paragraph 24).

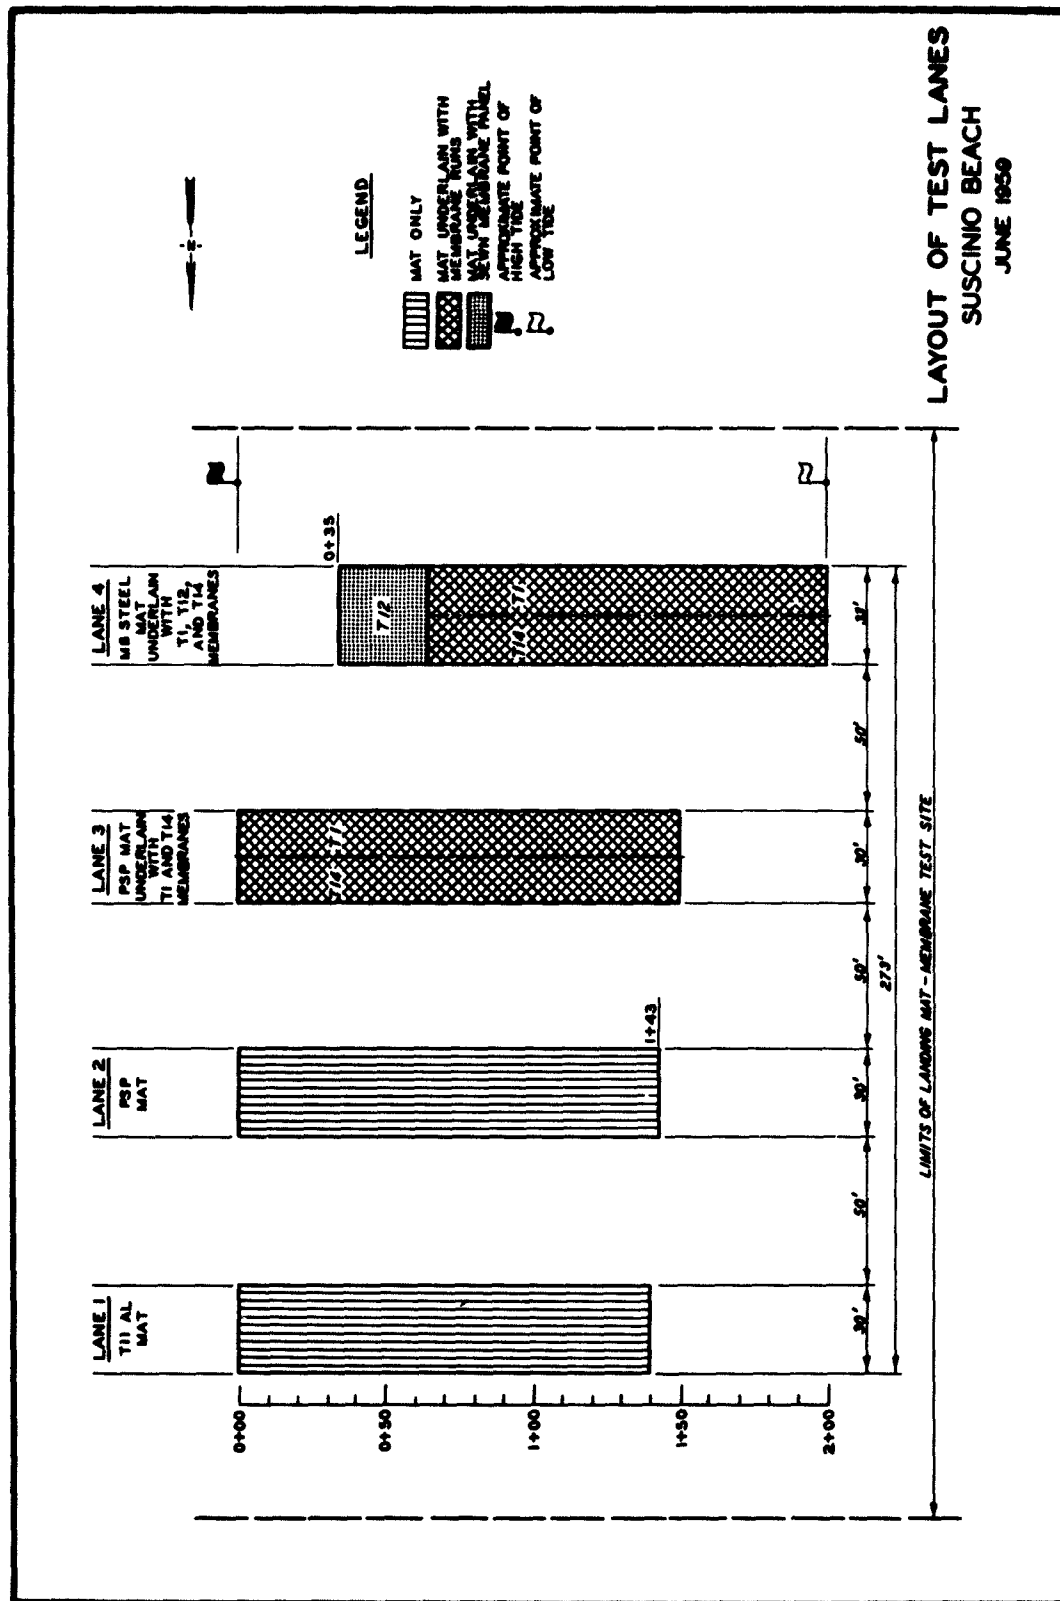
PLATE 14

36. Lane 3. Lane 3 was 150 ft long and surfaced with PSP underlain with T1 vinyl-coated cotton duck on the south half of the lane and T14 neoprene-coated nylon on the north half (see plate 14). The same procedures were used to place and anchor the membranes as were used at La Turballe. A crew of six men placed the membrane from sta 0+00 to 1+50 at an average rate of 1750 sq ft per man-hour. Immediately after placement of the membranes was completed, the PSP was placed directly upon these materials. Mat placement began at the offshore end of the lane and extended up the slope of the beach to sta 0+00. The PSP mat was in extremely poor condition because of use in previous NODEX operations and in the tests at La Turballe Beach. During the latter tests, numerous panels had become bowed and bent, and it was necessary to straighten them before they could be placed satisfactorily. When the mat was placed, several panels were discovered to be damaged excessively and it was necessary to discard them and carry additional panels onto the lane before placing could continue. The panels were staggered approximately 6 to 8 in. to prevent the ends being in line throughout the lane. A crew of six men placed the PSP at an average rate of 166.7 sq ft per man-hour. The entire operation of placing mat and membrane on the lane was accomplished at an average rate of 152.1 sq ft per man-hour.

underlain with T1 vinyl-coated cotton duck and T12 and T14 neoprene-coated nylon (see plate 14). The T1 membrane was placed on the south half of the lane and the T14 on the north half of the lane between sta 0+65 and 2+00. The 30-ft-square panel (sewn) of T12 nylon was placed at the inshore end of the lane between sta 0+35 and 0+65. The membranes were placed and anchored by the same procedures used at La Turballe Beach (paragraph 16). The sewn panel was carried onto the center of the lane and unfolded first across and then along the lane. All membranes were placed by an eight-man crew at an average rate of 1863 sq ft per man-hour. Fig. 17 shows the sewn panel and membrane runs prior to placement of the M8 mat on the lane. Immediately after the lane was surfaced with membranes, the M8 mat was placed directly upon these materials beginning at the offshore end of the lane (sta 2+00) and continuing to sta 0+35. Although the M8 mat had been used previously in the tests at La Turballe Beach and had been removed and transported to Susicinio for these latter tests, it was still in good condition with approximately 95 percent of the panels being completely undamaged. (Most of the

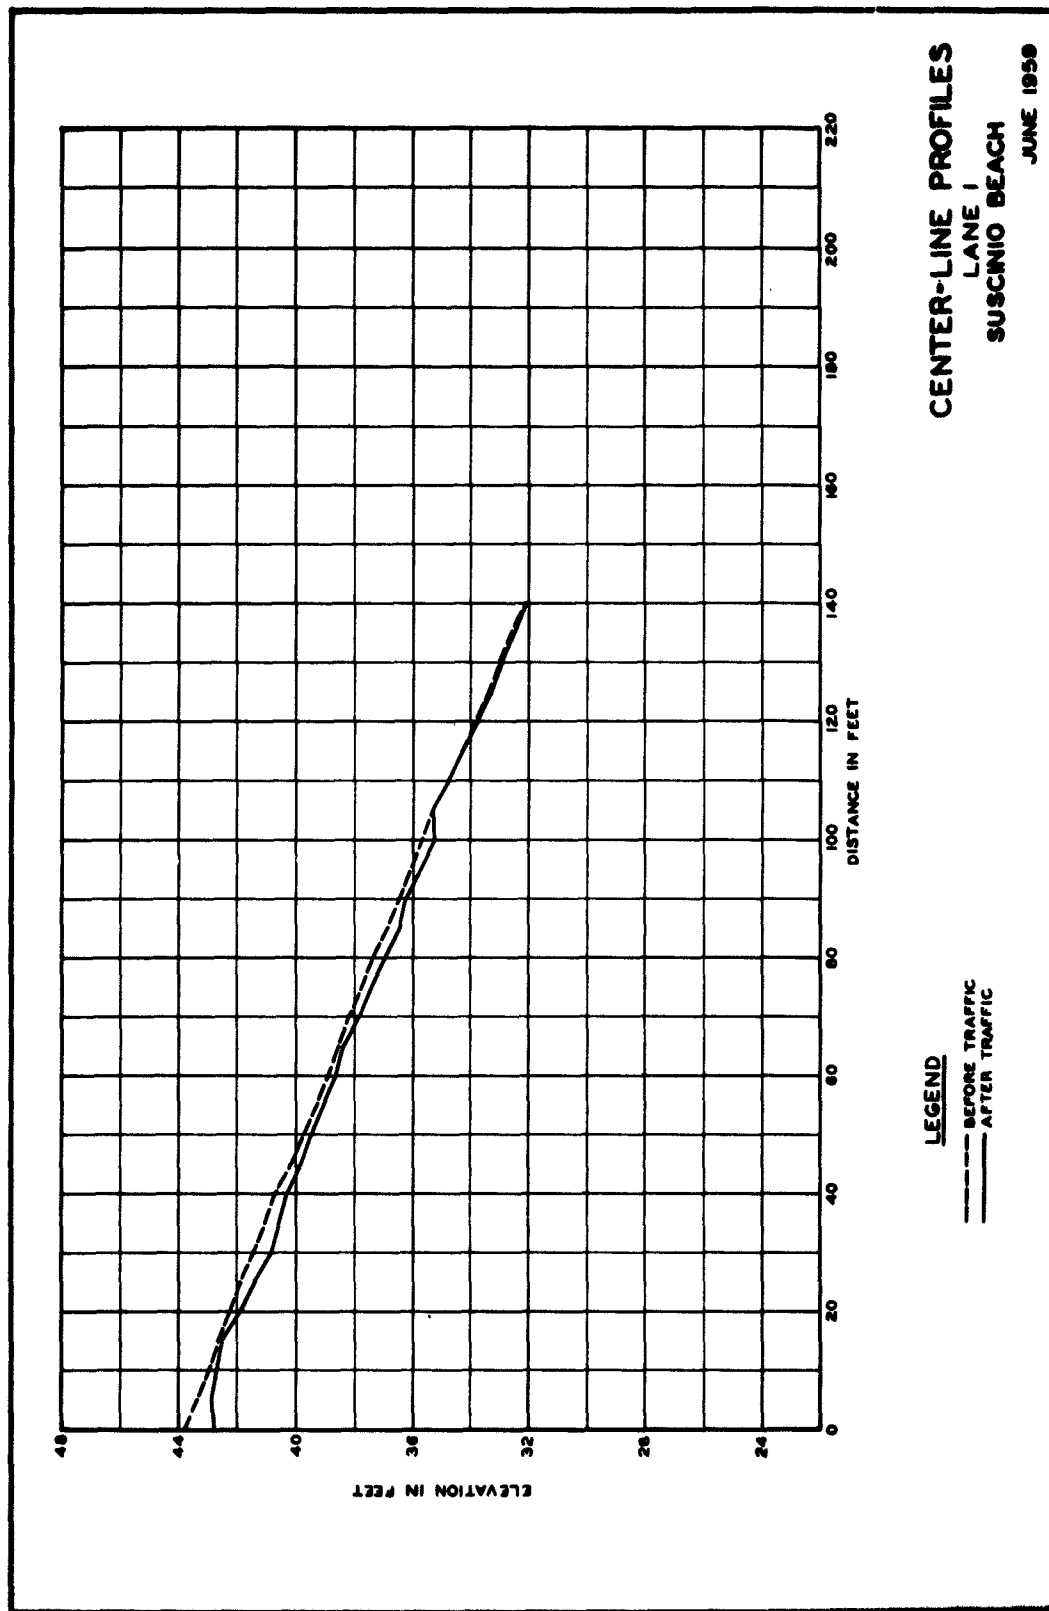
PLATE 18

46. At the conclusion of 1000 passes, the lane was in very poor condition (see photograph 30), but traffic could have continued. The surface of this lane was much rougher than that of lane 1 because of disengagement of panels at the side connections and general mat deformation. Some panel ends were curled upward about 12 to 15 in., and numerous spring clips were dislodged. Examination of plate 18 shows the extent of settlement of the mat.
